RAILWAY INVESTIGATION REPORT

R00T0257

CROSSING ACCIDENT

LIMEHOUSE, ONTARIO

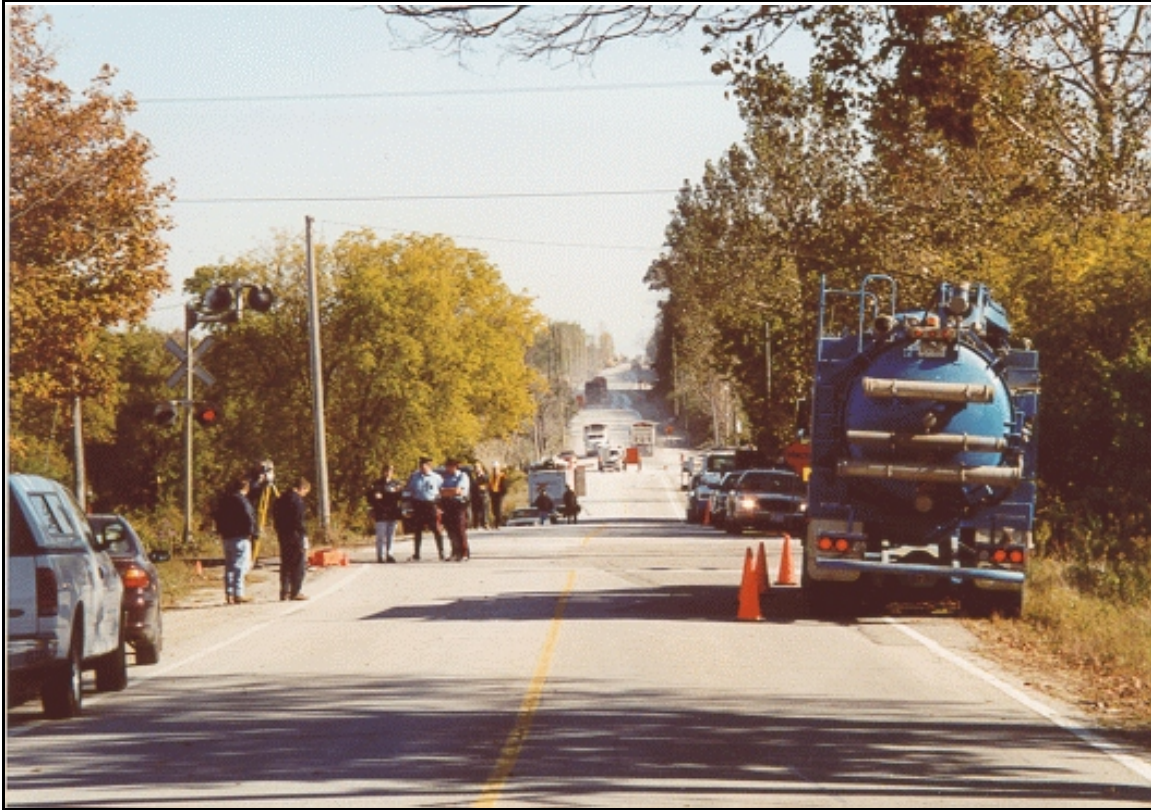
On the day of the occurrence, a job and safety briefing had been planned for 0630 in Acton, Ontario (Mile 5.3), with the 360networks TOP foreman, a 360networks sub-foreman and another 360networks employee, three A. van Egmond Construction Ltd. employees, two Ontario Excavac Inc. employees, and a CN signal maintenance person. This briefing was rescheduled, however, and was then to be held at the work site. The nine workers travelled to the work site in six vehicles—five light trucks and the Ontario Excavac Inc. truck. The light trucks were parked to the south of the crossing—four on the west side of the roadway and one on the east side (see Appendix A). The Ontario Excavac Inc. truck was parked and left running just to the north of the crossing at the expected work location. As per company policy, the driver placed pylons on the roadway to direct vehicular traffic around the truck. The truck was 10.9 m (36 feet) long, 2.6 m (8 feet 4 inches) wide, and 4.1 m (13 feet 5 inches) high (see Figure 1). This situation meant that southbound highway drivers would have to use part of the northbound lane to pass the Ontario Excavac Inc. truck.

Figure 1. Location of Ontario Excavac Inc. truck, looking southward.

The northwest crossing light signals were blocked by the truck and not visible to the driver. The rising sun obscured visibility of the southeast crossing light signals, and the driver's attention may have been distracted from these warning devices as he neared the crossing. The driver turned his head and looked to the right as he passed the front of the truck, indicating that his attention was directed away from the activated signal and the approaching train, both of which were to his left.

1. The driver drove onto the crossing and into the path of the train because the activated warning devices were either obscured, degraded, or discounted.

On 25 April 2001, the crossing signal protection was enhanced by the addition of automatic gates and constant warning time track circuitry.
